**Pantteg Landslip
Data Review and Management Proposals**

Pantteg Landslip Data Review and Management Proposals

Neath Port Talbot County Borough Council, The Quays, Brunel Way,
Baglan Energy Park, Neath, SA11 2GG

Document Reference: **ESP5859e.2393**

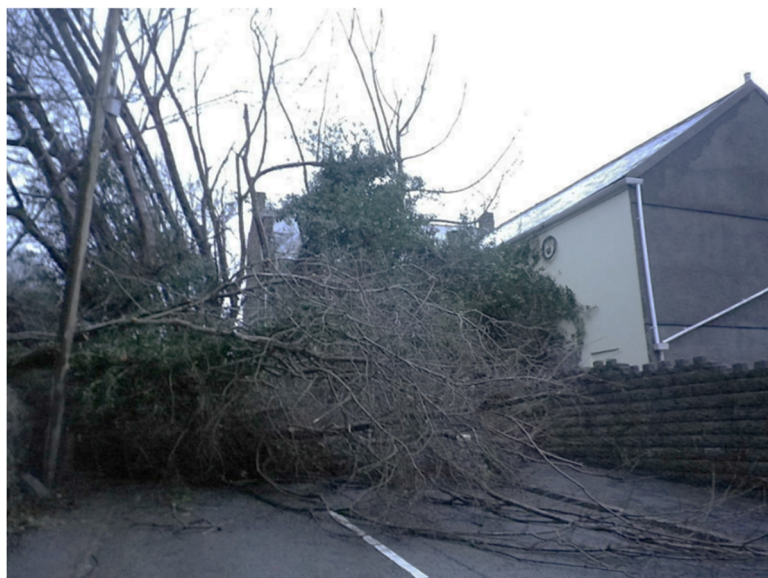
Figure 8: Landslip at Pantteg Chapel, December 2012, (Website accessed November 2015)

The most recent significant landslide occurred on 22 December 2012, and affected an area of Pantteg between Penygraig House and Pantteg Chapel, as shown in Figure 8. The landslide blocked the road at Pantteg Chapel, and partially blocked the road opposite 49 Pantteg. Access to Penygraig house was severed.

Following the 2012 landslide, the Client sought advice on appropriate remedial works at the site. The works undertaken comprised clearing the failed material from the highway and slope back to rockhead allowing the creation of a drainage ditch and berm at the foot of the slope, and a run-out area opposite the chapel. The works included the demolition of Penygraig House following the discovery of tension cracks up-slope of the house, and structural distress to the property.

The work supporting the strategy for the remediation work to address the failure states that it was difficult to identify the cause of the failure. Postulations on cause are offered and include contributions from naturally oversteep slopes, low strength superficial materials, leakage from the mine drainage system, collapse of old mine workings, preferential groundwater flows from the coal seams and extended periods of heavy rainfall through 2012.

The remedial works were to remove the immediate risk from the unstable material, to make the site safer and to reduce the risks that might be associated with further failure immediately upslope of the road and not to prevent any future slope failure.

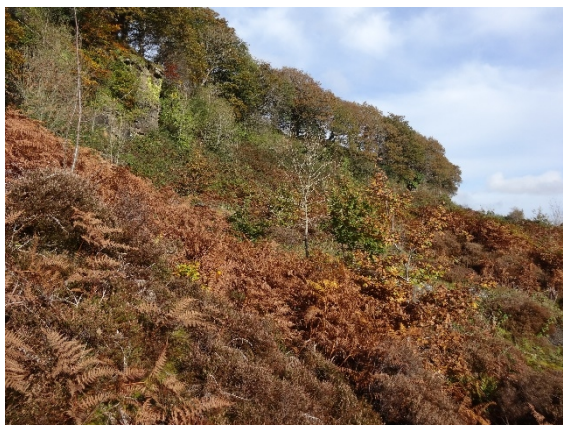
- Landslip backscarps (Figure 9);

Figure 9: Landslip backscarps above Pantteg Chapel

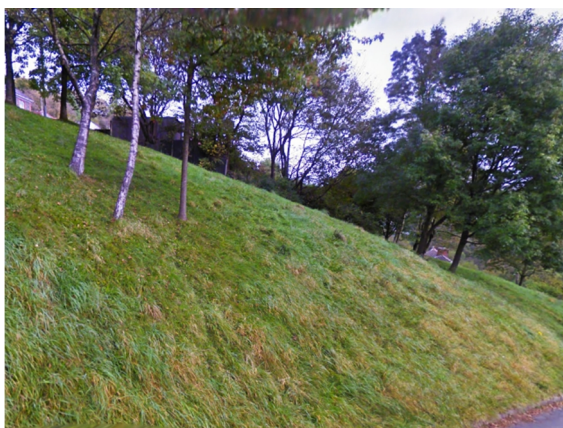
- Displaced blocks;
- Debris slides and debris flows;
- Landslip lobes (Figure 10);

Figure 10: Landslip lobes along Clees Lane

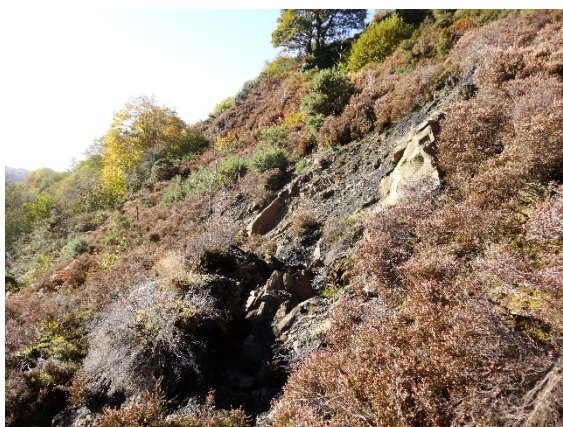
- Rotational slumps;
- Accumulation zones.
- Tension cracks (Figure 11);

Figure 11: Tension cracks above Pantteg Chapel
