**Pantteg Landslip
Data Review and Management Proposals**

Pantteg Landslip Data Review and Management Proposals

Neath Port Talbot County Borough Council, The Quays, Brunel Way,
Baglan Energy Park, Neath, SA11 2GG

Document Reference: **ESP5859e.2393**

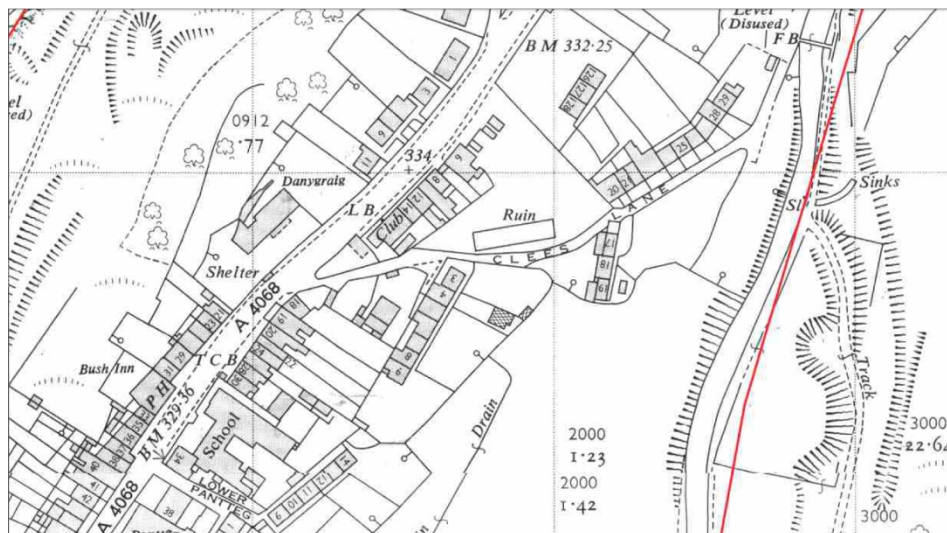
Figure 3: 1960 Historical Map

Evidence of ruins, possibly the result of ground instability, can be seen at various locations and points in time. The historical map excerpt reproduced as Figure 3 shows a ruin along Clees Lane in an area of known historical instability.

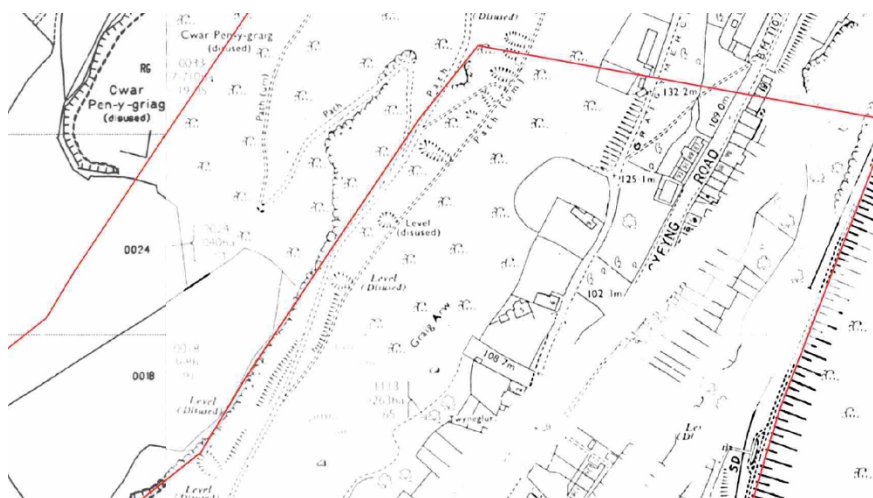
Figure 4: 1993 Historical Map Excerpt

The village of Pantteg has also been affected by ground movements, and the majority of the properties to the north-west of the road have been abandoned and or demolished due to ground movements. There are a few remaining properties, extending from the Chapel to Graig y Merched in Pantteg. The historical map excerpt below shows houses demolished on Graig y Merched following an earlier landslip (believed to have occurred in 1986).

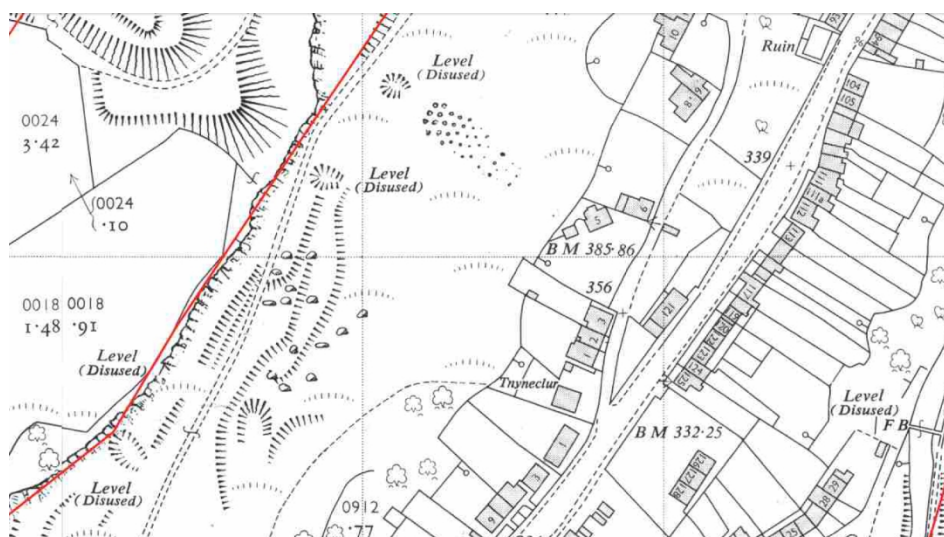
Figure 5: 1960 Historical Map Excerpt

There are several old coal levels recorded on the site, mostly to the west of Pantteg and Pantyffynnon. The 1918 Ordnance Survey map records two coal levels to the east of Clee Lane in Pantteg. An excerpt, shown in Figure 5, of the historical map of 1960 provides an example of the evidence of mining above Graig y Merched in disused levels.

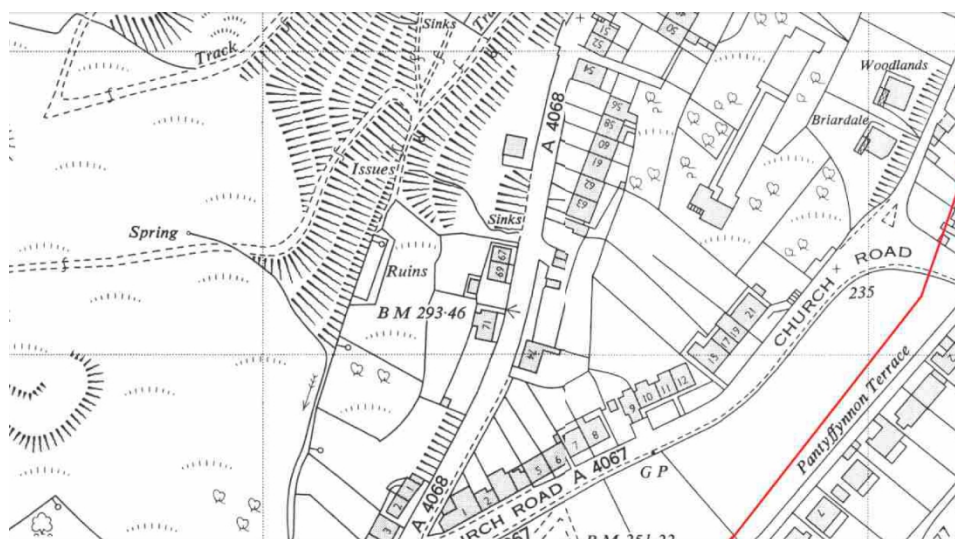
Figure 6: 1960 Historical Map Excerpt

An excerpt of the historical map of 1960 provides an example of the evidence of springs, issues, sinks above Cyfyng Road in Pantteg, and is shown in Figure 6.

The historical and most recent Ordnance Survey mapping indicates a number of springs across the wider landslip area. Previous assessments considered that these may be old coal mine entrances and the 'springs' are drainage points of mine water from adits. It should be noted that mine water is often acidic and therefore be a source of contamination.

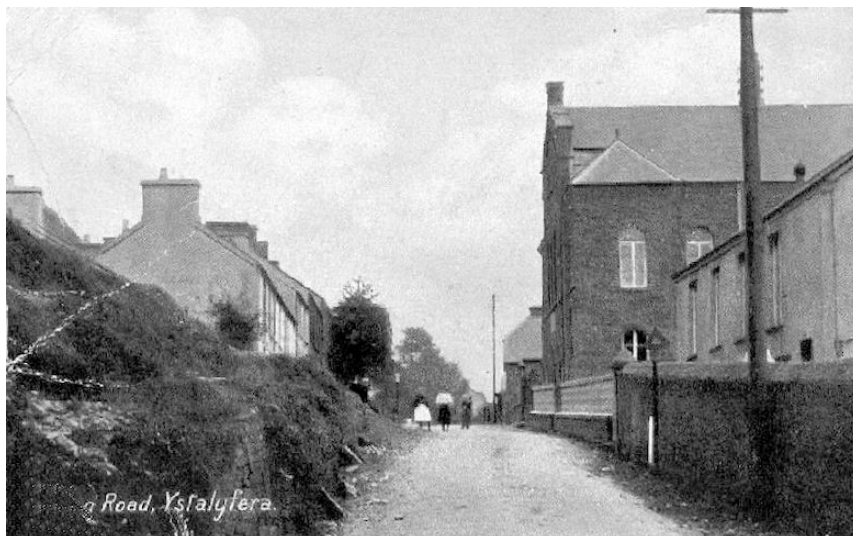
Figure 7: Undated Postcard of Pantteg Chapel (Ball, 2015)

The image from an undated postcard reproduced as Figure 7 below shows the general arrangement of the area of Pantteg Chapel, hall, slope toe morphology and historical

properties. The image shows the uneven/hummocky slope in its previous form and properties, which are now demolished, on the left.

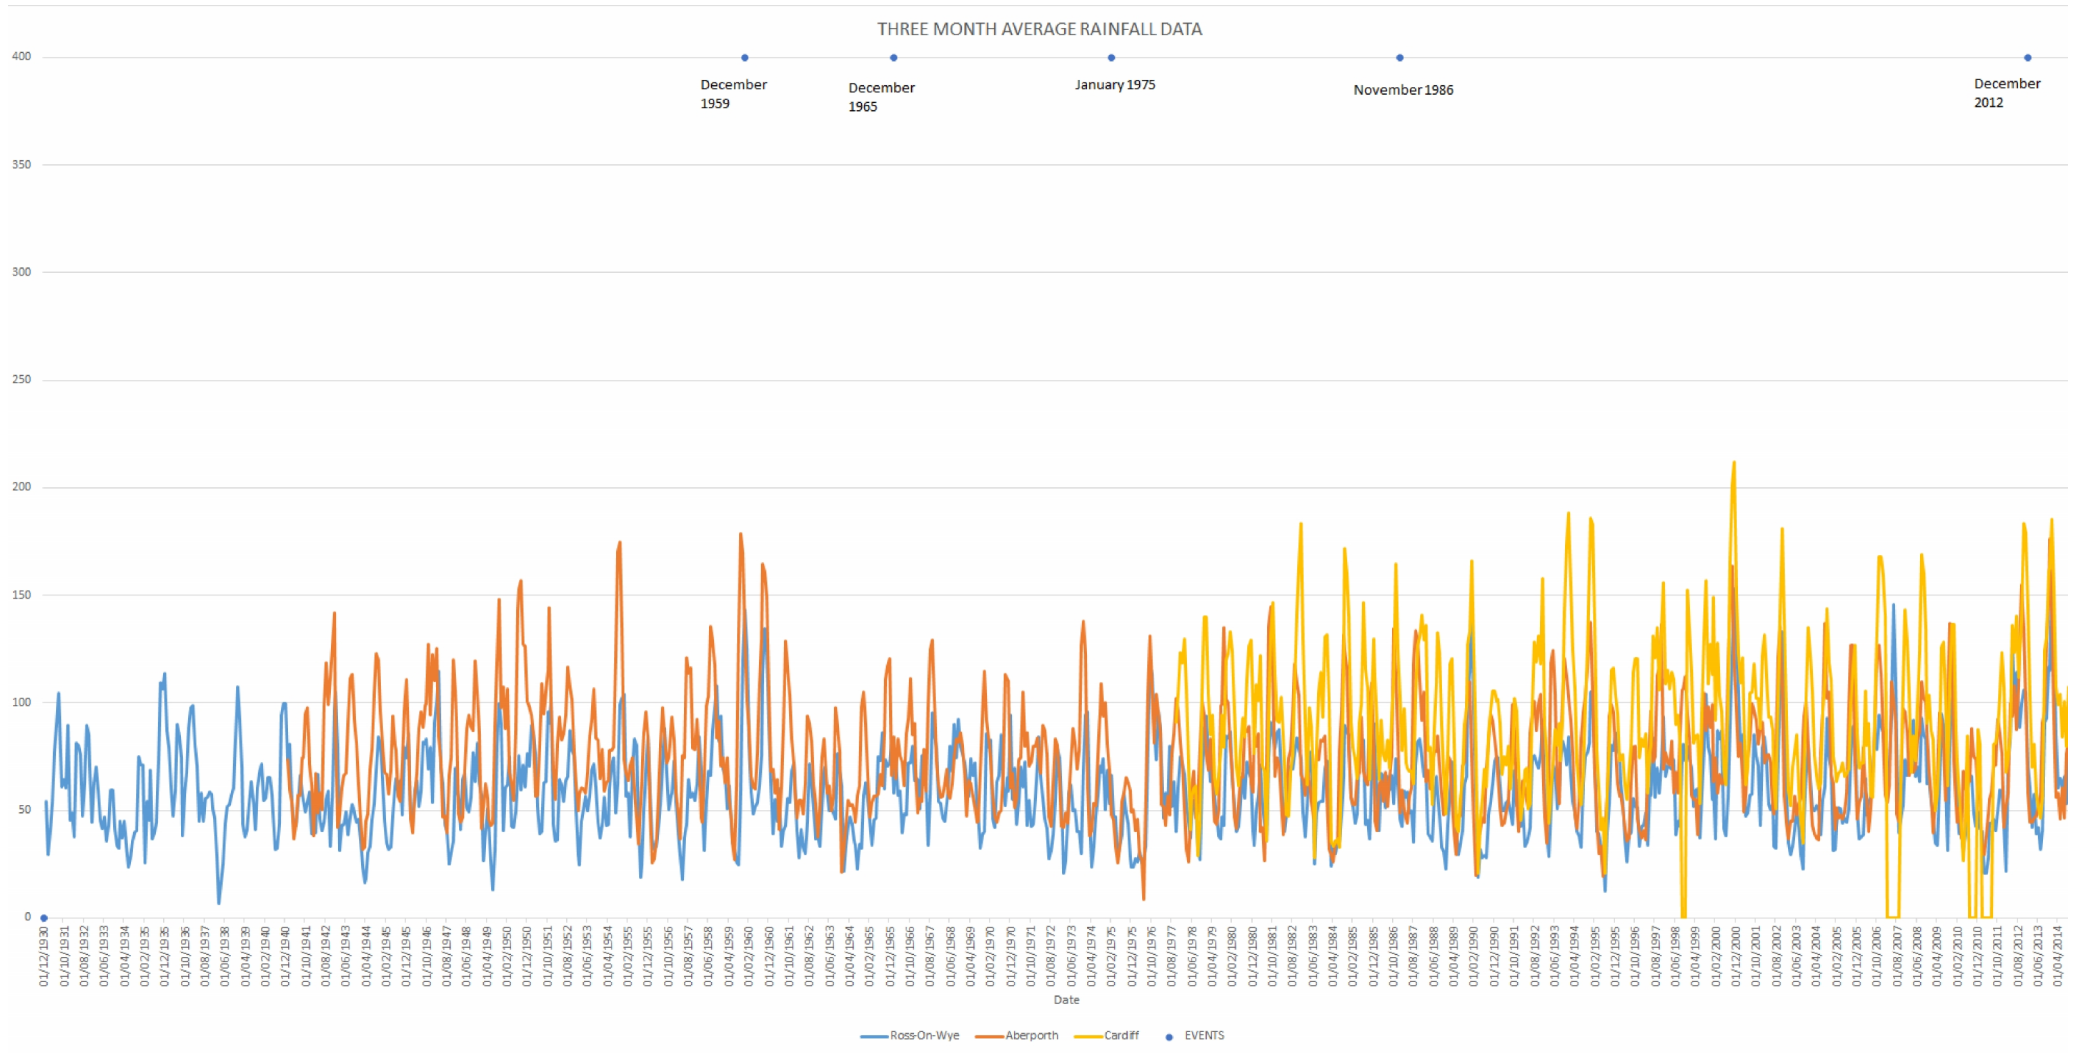
Graph1: Relationship between rainfall, river flow and landslide events: 1959, 1965, 1975, 1986 and 2012

No significant relationship between landslip events and longer-term rainfall trends has been established. However, for the December 1959, December 1965 and December 2012 events a general increasing rainfall trend is possibly present through the preceding years. Further comparison and discussion of rainfall data, river flow data and instability is provided in Section 4.6.1.

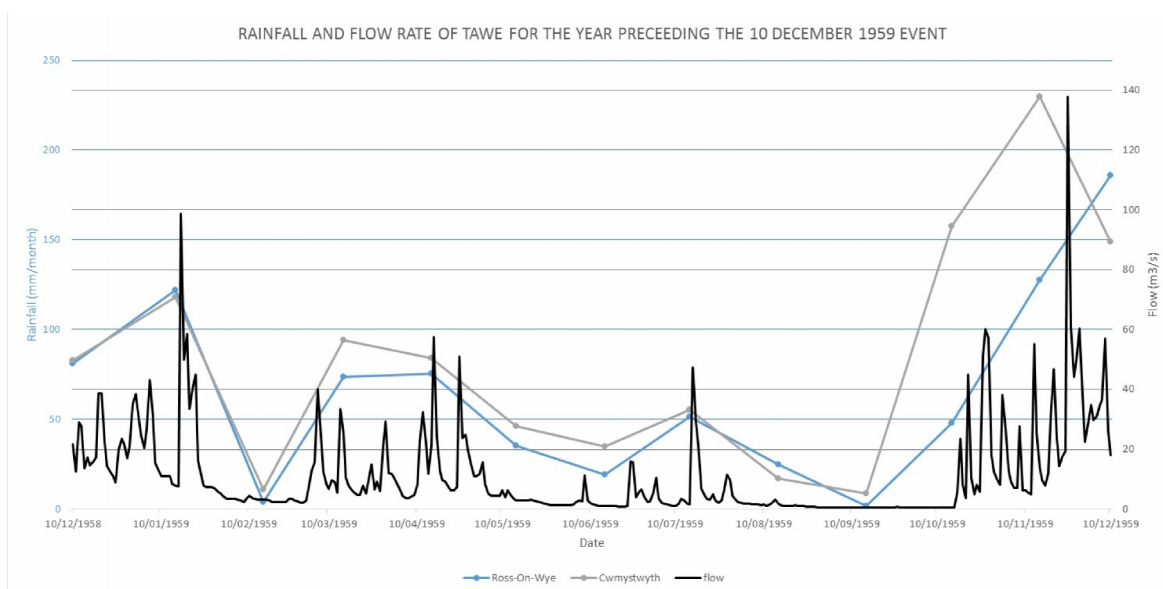
Graph 2: Rainfall and Flow Rate for the year preceding the 10th December 1959 event

Average annual rainfall appears low compared to the other selected events.

It can be seen that during the autumn period, rainfall increases steadily with a response seen in river flows. River flow exceeds 100m³/s prior to the landslip event.

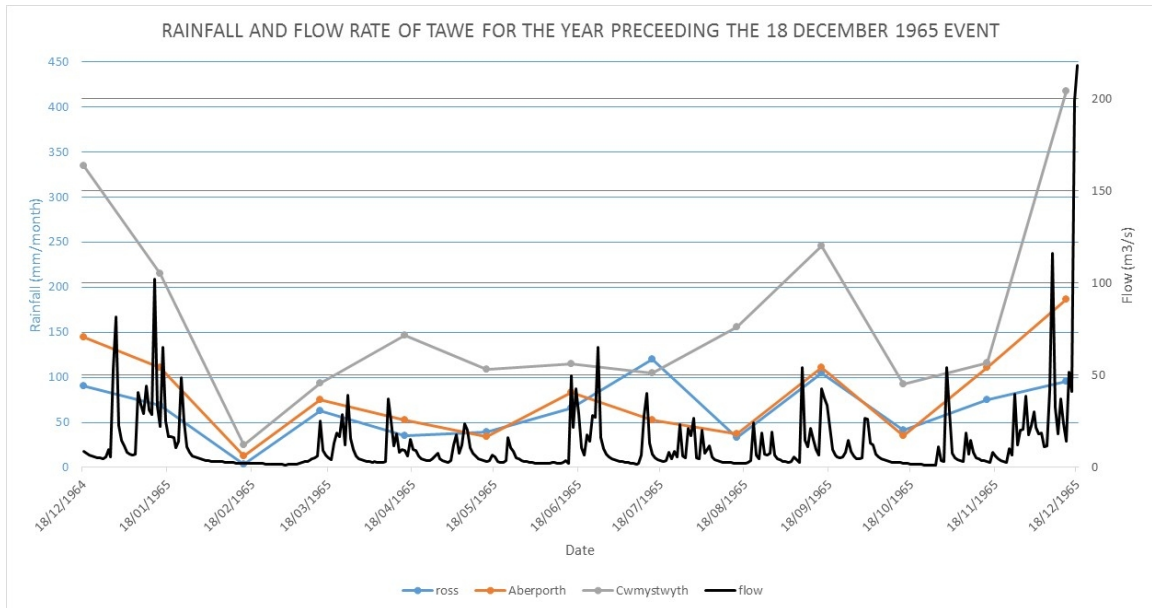
Graph 3: Rainfall and Flow Rate for the year preceding the 18th December 1965 event

Average annual rainfall appears moderate compared to the other selected events.

It can be seen that during the autumn period, rainfall decreases steadily. Rainfall increased notably during November and December 1965, with a response seen in river flows. River flow exceeds 100m³/s prior to the landslip event.

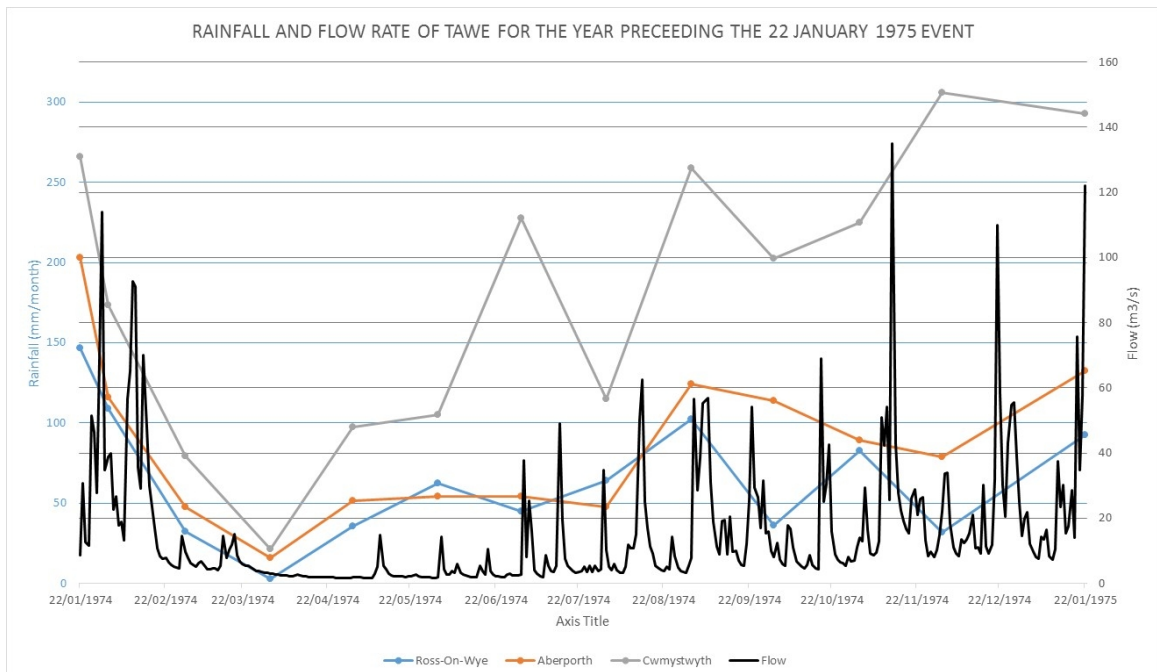
Graph 4: Rainfall and Flow Rate for the year preceding the 22nd January 1975 event

Average annual rainfall appears moderate compared to the other selected events. However, Cwmystwyth records notably higher rainfall. It can be seen that during the autumn period, rainfall increases steadily.

Rainfall increased notably during November and December 1965, with a response seen in river flows. River flow exceeds 100m³/s prior to the landslip event. 100m³/s river flow is also exceeded twice during November and December 1974.

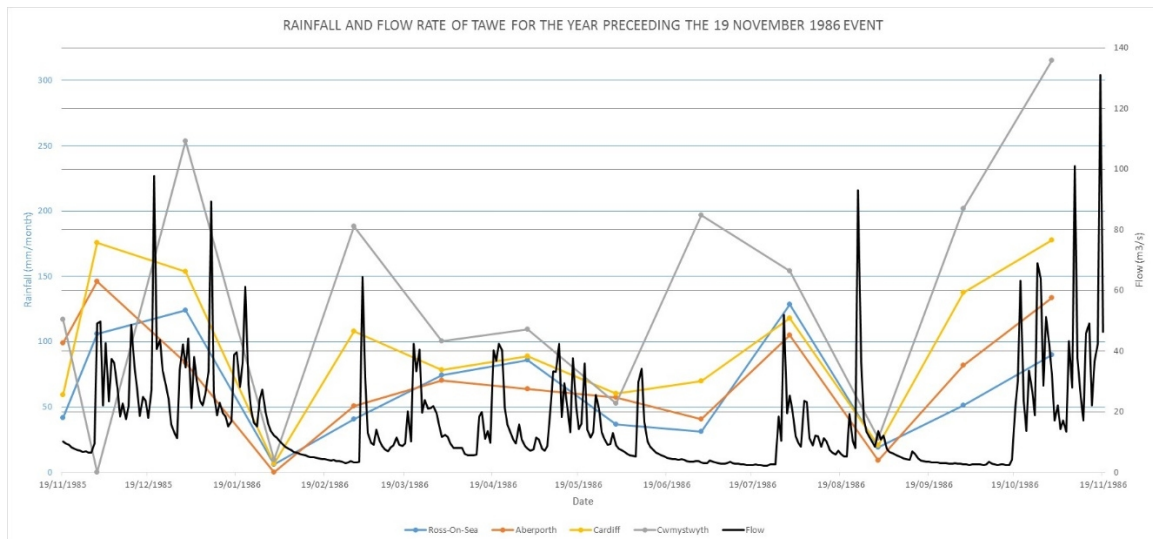
Graph 5: Rainfall and Flow Rate for the year preceding the 19th November 1986 event

Average annual rainfall appears higher compared to the other selected events. Cwmystwyth again records notably higher rainfall. It can be seen that following a drier August/September period, rainfall increases steadily through the autumn.

Rainfall increased notably during October and November 1986, with a response seen in river flows. River flow exceeded 100m³/s during the dry August/September and this may have been due to a very high intensity storm. River flow exceeded 100m³/s prior four times prior to the landslip event.

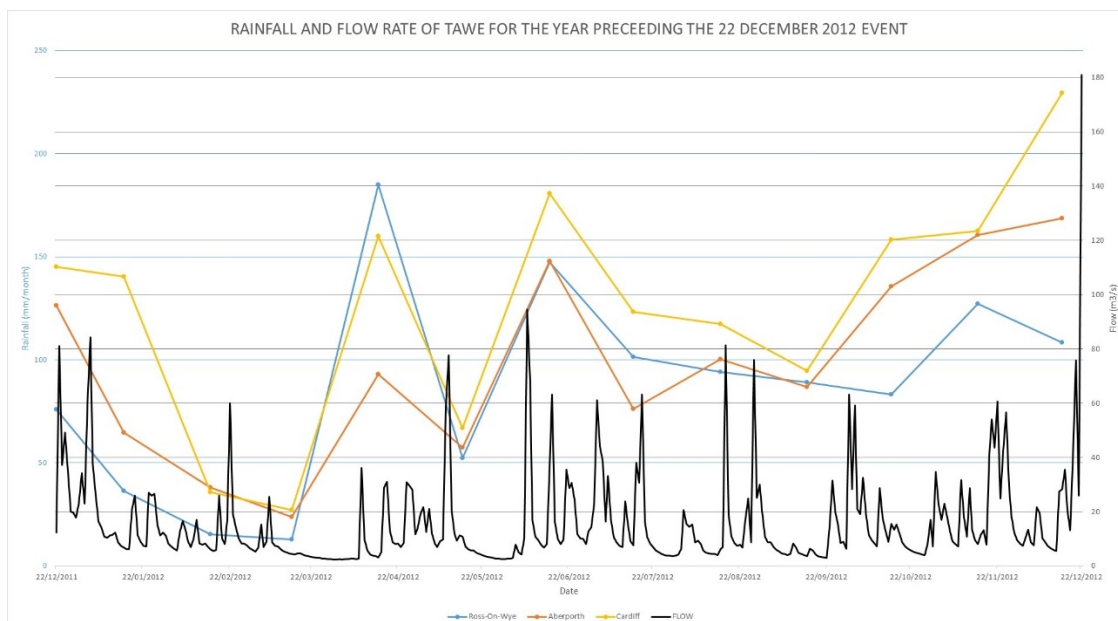
Graph 6: Rainfall and Flow Rate for the year preceding the 22nd December 2012 event

Average annual rainfall appears higher compared to the other selected events. Cwmystwyth data has not been included. It can be seen that following a wetter summer period, rainfall increases steadily through the autumn.
